CHAPTER-10

# Using Digital Methods on Cultural Heritage Conservation- Case Study Erzurum

#### Dr. Tuna KAN<sup>1</sup>

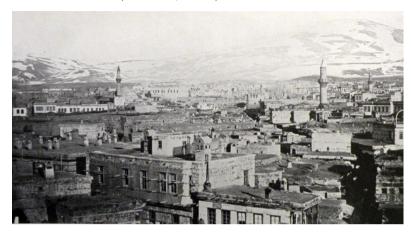
**Figure 4:** A panoramic view from Erzurum (H. Hepworth, Through Armenia on horseback, London, 1898, URL11).

The masonry structures of Erzurum houses, which have a different structure from the typical Turkish House character, also make it difficult to document these structures (Figure 4). For this reason, 3D laser scanning method was used together with conventional methods in the survey studies. Most of the buildings in the project area have been abandoned. Within the scope of autenticity and integrity, it has been determined that some parts of the buildings, which are in a very bad condition, were demolished or completed using non-autentic materials. During the creation of the Restitution Projects, it has been tried to reach the autentic state of the building by analysing the autentic parts and through the existing traces and old documents that can be found (Figure 5). On the other hand, it was aimed to restore the buildings to

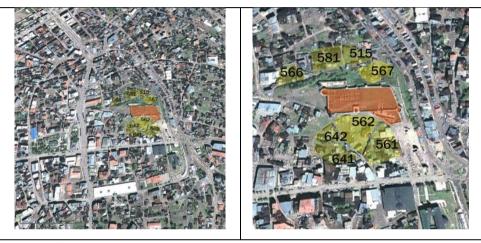
**Figure 8, 9:** Location of the Blocks with Surveyed Buildings (googlearth-2012)

Before the fieldwork, office work was carried out and planning was made regarding the study team and data collection method. Study groups and measurement methods were planned by examining the layout sheet and satellite photograph, the building layout area and the state of the building (Figure 7, 8, 9). The planning was made for a short time and to be completed in a few times considering the climatic conditions of the area such as cold weather and daylight duration.

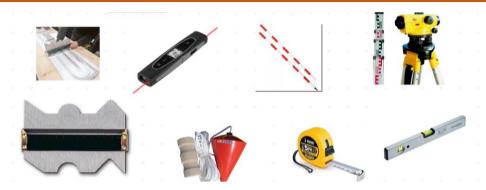
Figure 10: Instruments used in conventional measurement.

Measurements are taken by meters, plumbing, and scales in conventional methods. Starting from a point in the area, continuous measurements are taken in a clockwise direction. Before starting the measurement, +1 m level is marked or drawn horizontally by pulling a rope horizontally so that the level differences on the ground do not cause wrong measurement, then the continuous measurements are supported with diagonal measurements. Diagonal measurement ensures that each measuring point is verified by measuring from a reference point at least twice. Measurements are taken with a profile comb for architectural details such as doors, windows and ceiling profiles. A sketch is drawn and the dimensions are engraved on it (Figure 10).

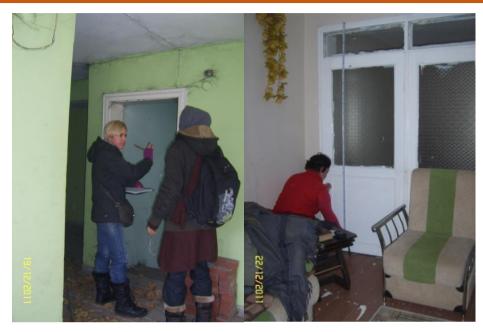
Figure 11. Indoor measurement studies with conventional methods.

Conventional methods are used exclusively or in combination with digital methods, depending on the characteristics of the structure studied. The work on the structures around Erzurum Castle was started in December 2011. The survey of 14 buildings on 22 parcels was conducted using terrestrial laser scanning and conventional methods together. Restoration Specialist Project Manager (1), 6 Architects, 6 Restorers, 2 surveyors and 4 surveyors took part in the project. The field program was carried out by the survey team taking the external measurements with laser and the architect-restorer team measuring with sketches and conventional methods . This method has been followed, considering that the laser scanning device will not work comfortably due to internal debris, furniture, etc. reasons. The digital method was also used in the interior measurements of the buildings where the interior space is empty. Conventional measurements were made with teams of 3 people. Measurement studies in the field have progressed in 3 times with 5-day planning (Figure 11. 12).

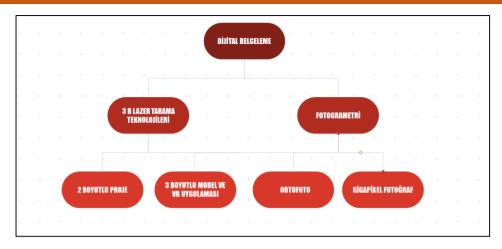
Figure 14. Digital documentation methods

Digital documentation methods, which we call advanced documentation methods, have developed with photogrammetry and lidar techniques (Gulec, et al., 2011, Alshawabkeh, et al., 2023). These 3D documentation methods, which enable the virtual transfer of the field to the office, greatly facilitate the work of architects and eliminate measurement errors. With the software developed today, it has become possible to produce and combine the data obtained in both methods as a "3D point cloud". In this way, the data of the field taken from different angles are combined on the same platform and can be vectorised (Figure 14).

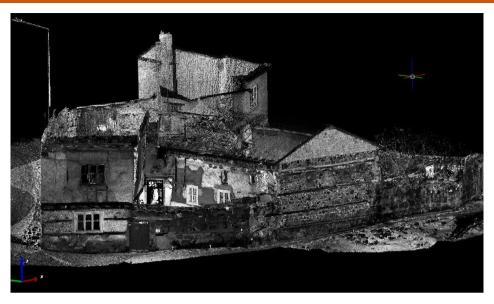
Figure 17: Terrestrial survey studies

Pre-processing data consists of two stages. The first stage is the stage in which the data obtained from a large number of laser scanning sessions are combined. It is the stage of colorization by the colours assigned from the photographs taken by the camera placed on the top of the laser scanner and laser point clouds are georeferenced and combined with the precision of 2mm (Figure 17-18).

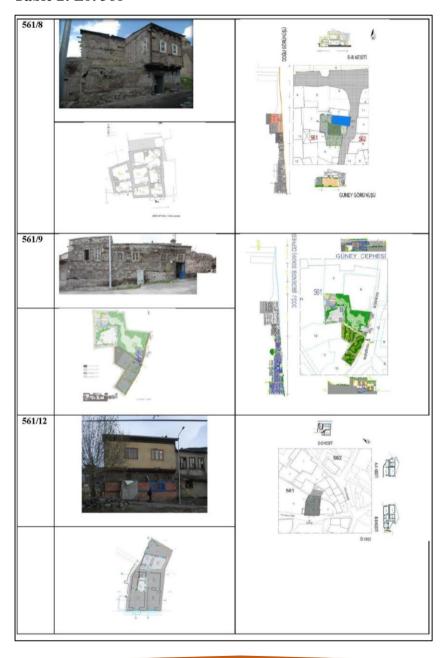
**Table 3:** Lot 562

General information about the Architectural Cultural Heritage Examples on the 9 blocks located around the Castle, which was studied within the scope of the project, is given in the tables below. The assets in the study area are named according to the lot and parcel numbers and projected. Tables includes the street view, location and ground floor plan of the buildings. (Table 2-11)

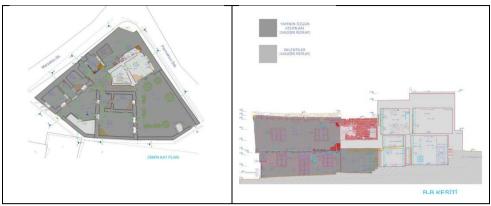
**Figure 25:** Studies before restitution (data from the property), analytical survey section-view

The analysis of the original parts and the parts added later is an important step in the conservation process. Before the restitution work to be carried out after the survey work, historical research, comparative studies and period analyses are made about the building and its surroundings (URL9, Tek Yapı Ölçeğinde Rölöve, Restitüsyon Ve Restorasyon Projeleri Teknik Şartnamesi, 2023)
